## **APPENDIX G**

### **DPR Forms**

State of California — The Resources Agency  
DEPARTMENT OF PARKS AND RECREATION  
**PRIMARY RECORD**

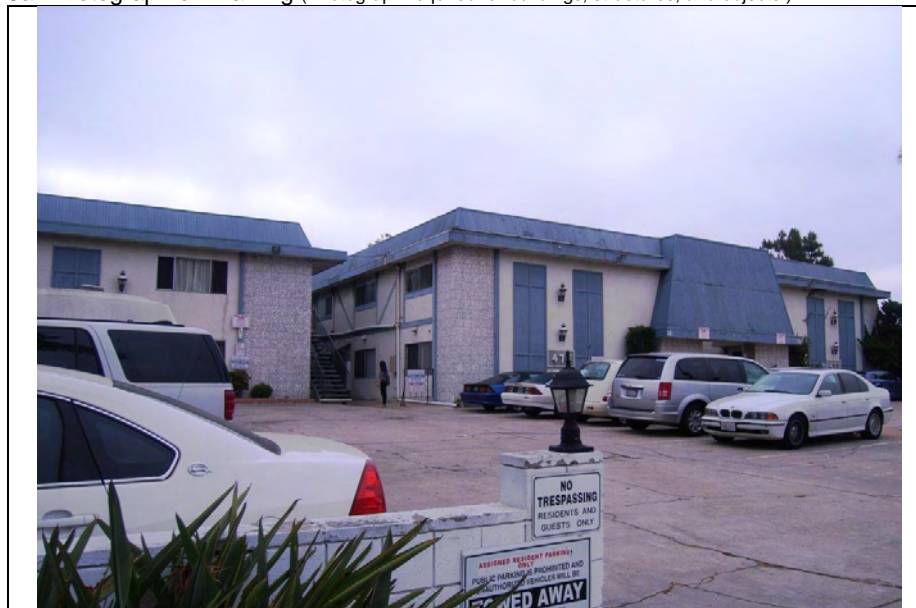
P5a. Photograph or Drawing (Photograph required for buildings, structures, and objects.)

View looking southeast at the building.

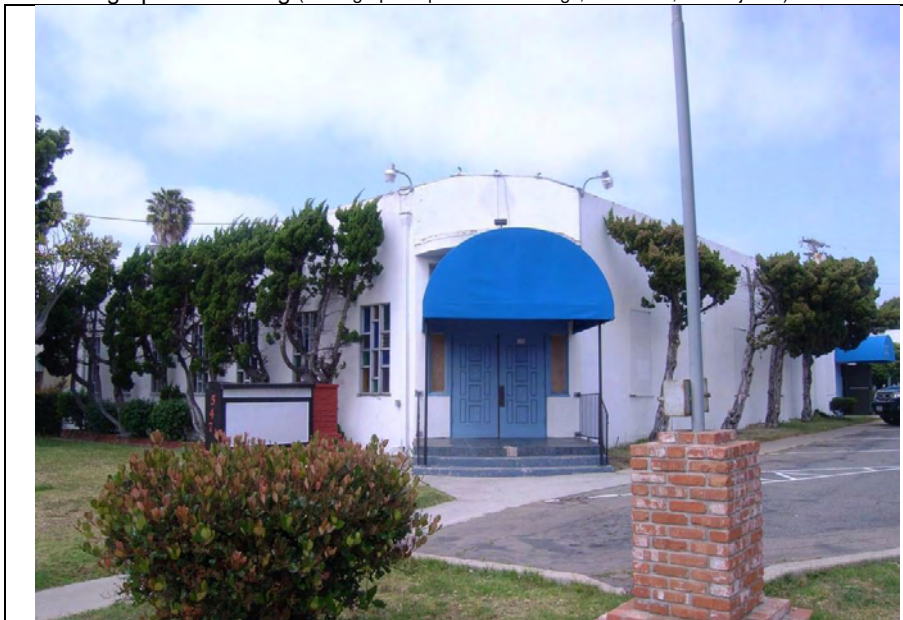
P5a. Photograph or Drawing (Photograph required for buildings, structures, and objects.)

View looking northeast at the building.

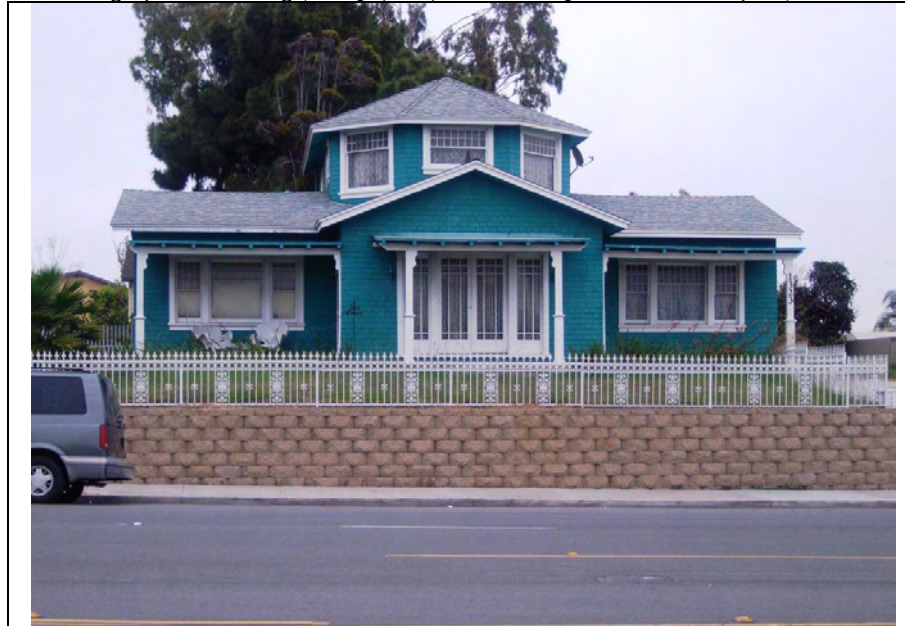
P5a. Photograph or Drawing (Photograph required for buildings, structures, and objects.)

View looking east at the building.

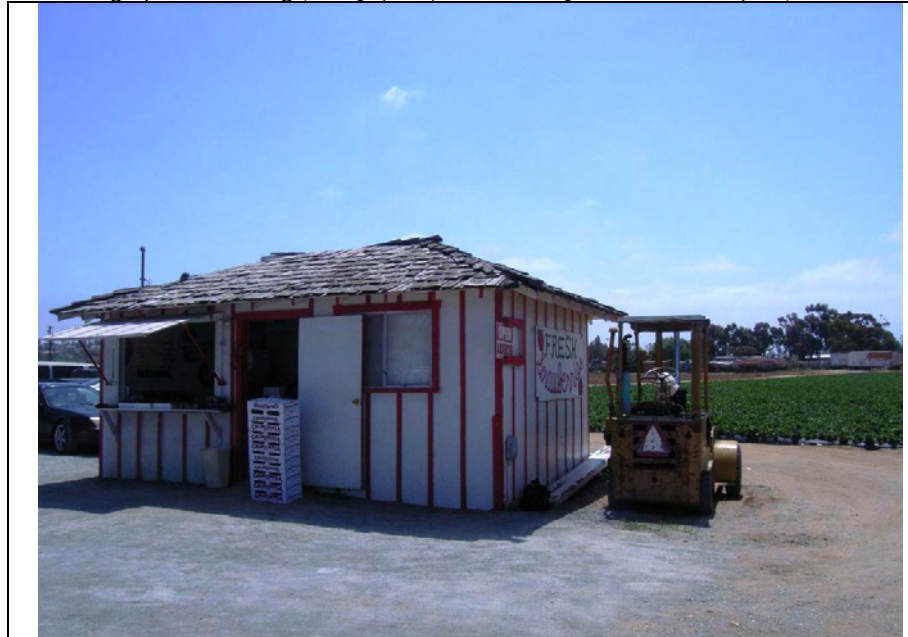
P5a. Photograph or Drawing (Photograph required for buildings, structures, and objects.)

View looking west at the building.

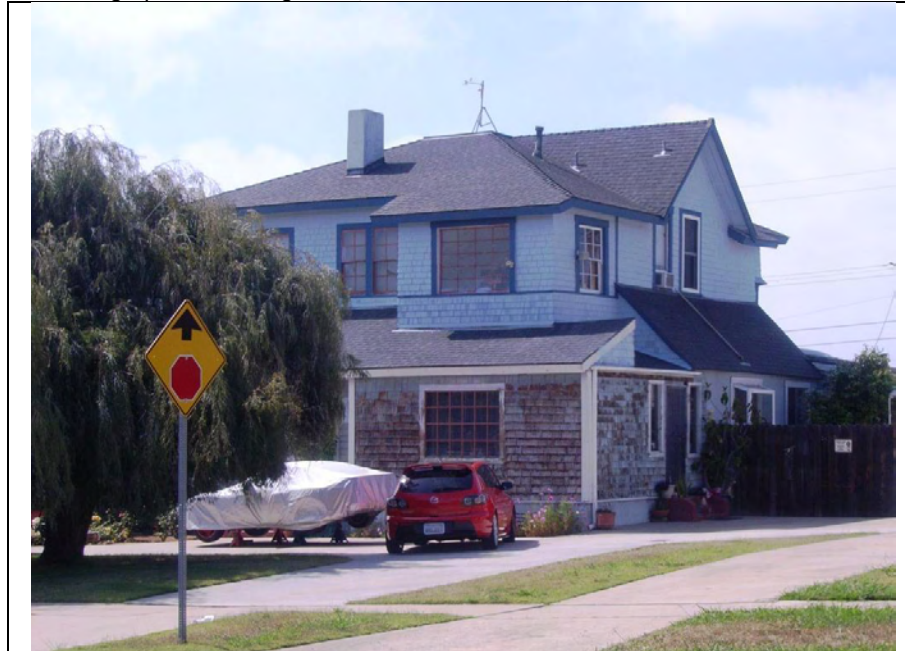
P5a. Photograph or Drawing (Photograph required for buildings, structures, and objects.)

View looking north at the building.

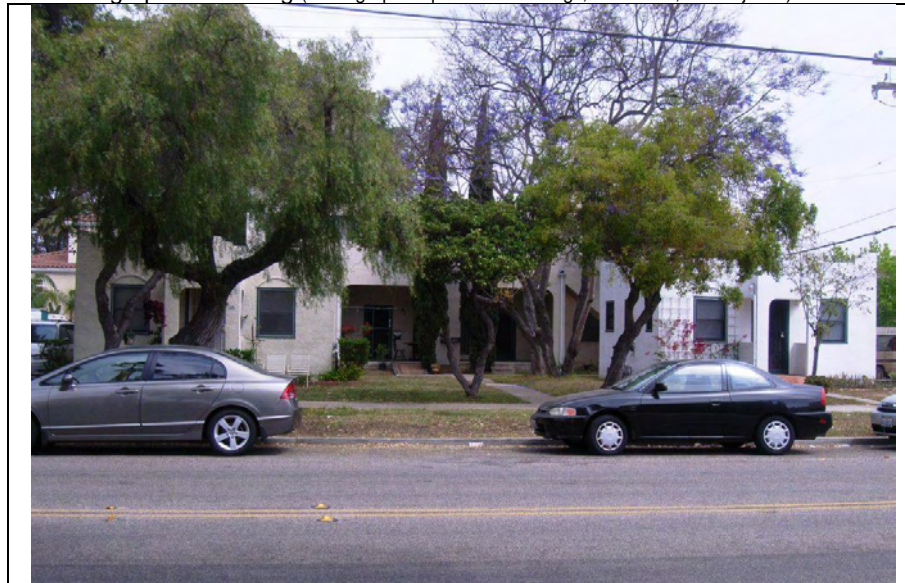
P5a. Photograph or Drawing (Photograph required for buildings, structures, and objects.)

View looking north at the buildings.

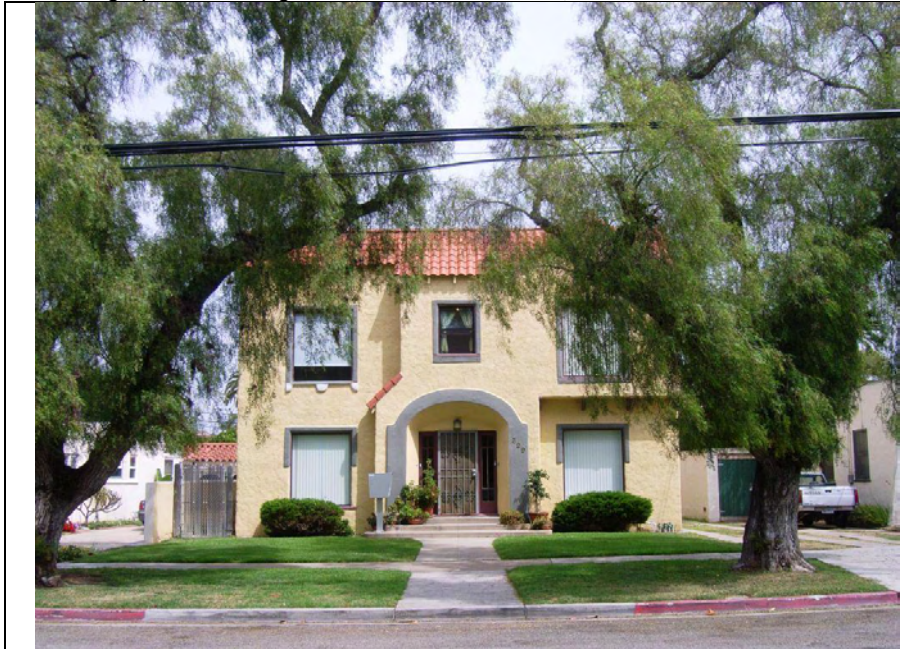
329 G Street was constructed in 1937 in the Spanish Colonial Revival style. It is a two-story multi-family residential building located on the north side of G Street. The residence has a wood frame, rectangular floor plan with a concrete foundation. The exterior is clad in stucco siding. The roof is flat with a raised pent roof parapet with shallow eaves and clad in red clay tiles. On the south elevation, a concrete walkway and steps lead to a partial-width recessed porch with an arched hood. The primary entrance is located within the porch and consists of a single wood door with sidelights. The windows consist of fixed plate glass windows. There are decorative window surrounds. Modifications to the building include the replacement windows. Landscape features include a front grass lawn and side concrete driveway.

View looking north at the building.

329 G ST is recommended eligible as a Chula Vista Historic Resource under NRHP, CRHR and local criteria. In considering the building within the historic context prepared for this survey, it does not appear to be associated with any significant themes or patterns in history and therefore not eligible for Criteria A or 1. Additionally, no significant persons were identified in association with the property and it is not recommended eligible under Criteria B or 2. 329 G ST as an excellent local example of the Spanish Colonial Revival style, and as such is recommended eligible as a Chula Vista Historic Resource under Criterion 3. Character defining features of the Spanish Colonial Revival style include the stucco walls, red clay tile roofing, large wooden corbels. Following the same reasons, it is also eligible for the California Register of Historical Resources and National Register of Historic Places, on the local level, under Criterion 3 (CRHR) and Criterion C (NRHP). The building retains a significant degree of its building materials dating to the period of significance, especially in comparison to other similar properties. Overall it retains a high degree of integrity, especially of design, materials, and craftsmanship.

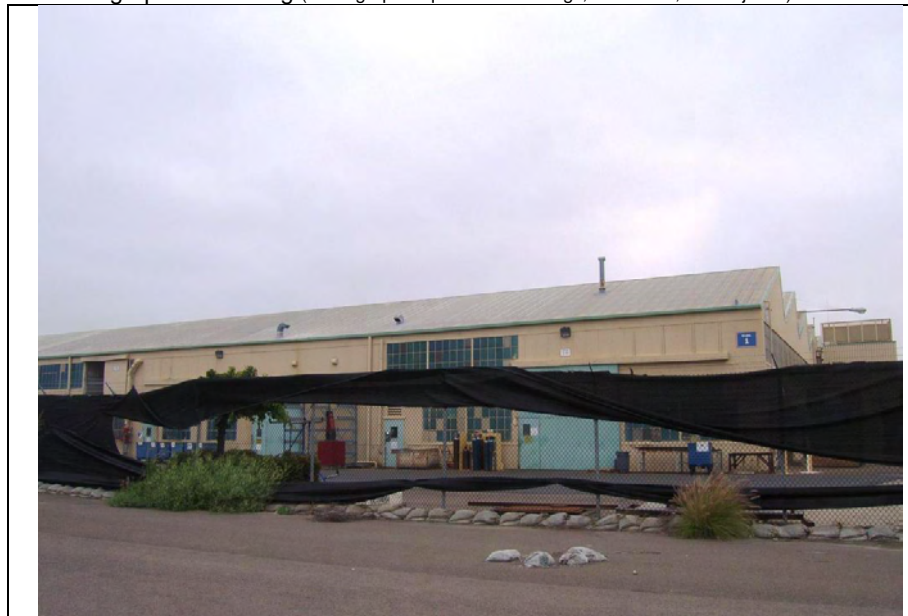
The Rohr Complex on G Street was constructed circa 1950 in the Modern non-residential style. It is a one-story industrial building located on the west side of G Street. The industrial building has a steel frame, rectangular floor plan with a concrete foundation. The exterior is clad in corrugated metal sheet siding. The roof has a series of slanted roofs. The windows consist of multi-light glass block and metal windows. No other features of the building could be seen from the street at the time of the survey. A parking lot surrounds the building. Several additions have been constructed adjacent to the building; all are one story additions with metal sheeting. There is one other building on the parcel lot with concrete siding and appears to be new construction.

View looking west at the building.

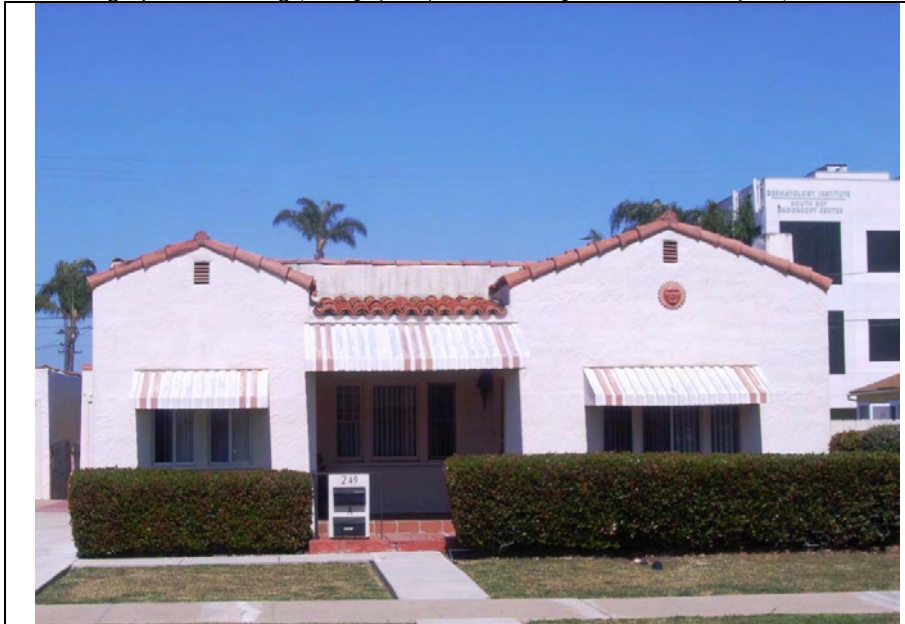
249 Garrett was constructed circa 1930 in the Spanish Colonial Revival style. It is a one-story single family residential building located on the north side of Garrett Avenue. The residence has a wood frame, rectangular floor plan with a concrete foundation. The exterior is clad in stucco siding. The roof is flat with coping and have two gable-front projections on the primary façade. On the south elevation, a concrete walkway and tile steps lead to a partial-width recessed porch. There are metal awnings over the porch entryway and two main façade windows. The primary entrance is located within the porch and consists of a single door. The windows consist of vinyl slider and wood sash windows. There is one chimney on the east elevation exterior lateral. Additions include a one-story flat roof addition at the rear of the building. Modifications to the building include replacement windows and doors. Landscape features include a front yard and a side driveway.

View looking east at the building.

249 GARRETT AV is not recommended eligible as a Chula Vista Historic Resource under any NRHP or CRHR or local criteria. In considering the building within the historic context prepared for this survey, it does not appear to be associated with any significant themes or patterns in history and therefore not eligible for Criteria A or 1. Additionally, no significant persons were identified in association with the property and it is not recommended eligible under Criteria B or 2. Although 249 GARRETT AV possesses some stylistic features of the Spanish Colonial Revival style, it is not a good representative of the style and is not recommended eligible under Criteria C or 3.

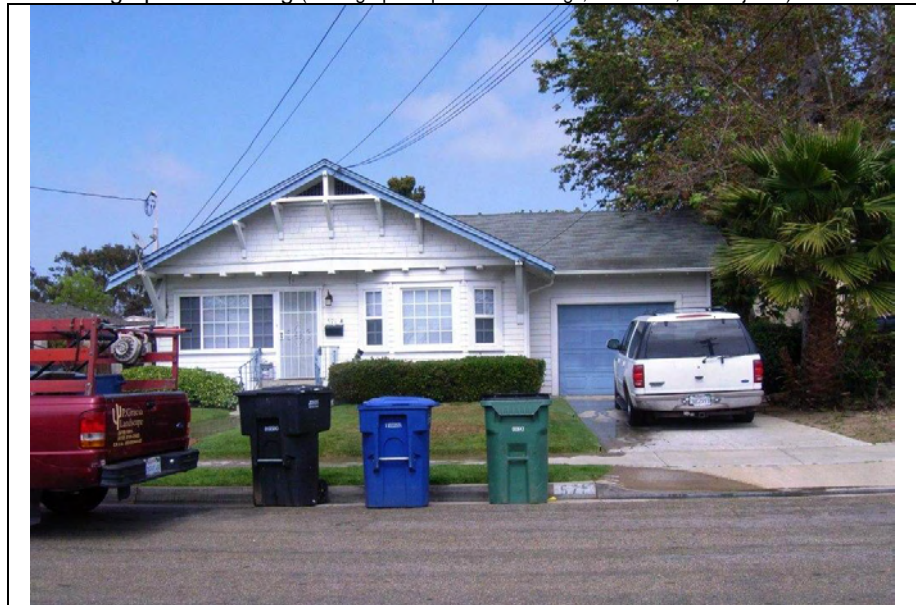
571 Glover Street was constructed in 1928 in the Craftsman style. It is a one- and one-half story multiple residential building located on the east side of Glover Street. The residence has a wood frame, rectangular floor plan with a concrete foundation. The exterior is clad in horizontal wood board siding and split wood shingles underneath the gable ends. The roof is a moderately-pitched front gable roof with widely-overhanging eaves and exposed rafter tails and clad in a composition roll. On the west elevation, a concrete walkway and steps lead to a partial-width uncovered stoop with metal railings. The primary entrance consists of a single door that is obscured by a metal security door. The windows consist of vinyl sash and sliding windows. Decorative features of the building include large knee brackets and exposed purlin ends. There is also a front gable dormer on the north elevation. Additions include a side garage on the south elevation. Modifications to the building include the replacement of doors and windows. Landscape features include a front yard and bushes. There is also a two-story detached addition with apartments located to the rear of the property lot.

View looking east at the building.

571 GLOVER AV is not recommended eligible as a Chula Vista Historic Resource under any NRHP or CRHR or local criteria. In considering the building within the historic context prepared for this survey, it does not appear to be associated with any significant themes or patterns in history and therefore not eligible for Criteria A or 1. Additionally, no significant persons were identified in association with the property and it is not recommended eligible under Criteria B or 2. Although 571 GLOVER AV possesses some stylistic features of the Craftsman style, it is not a good representative of the style and is not recommended eligible under Criteria C or 3.

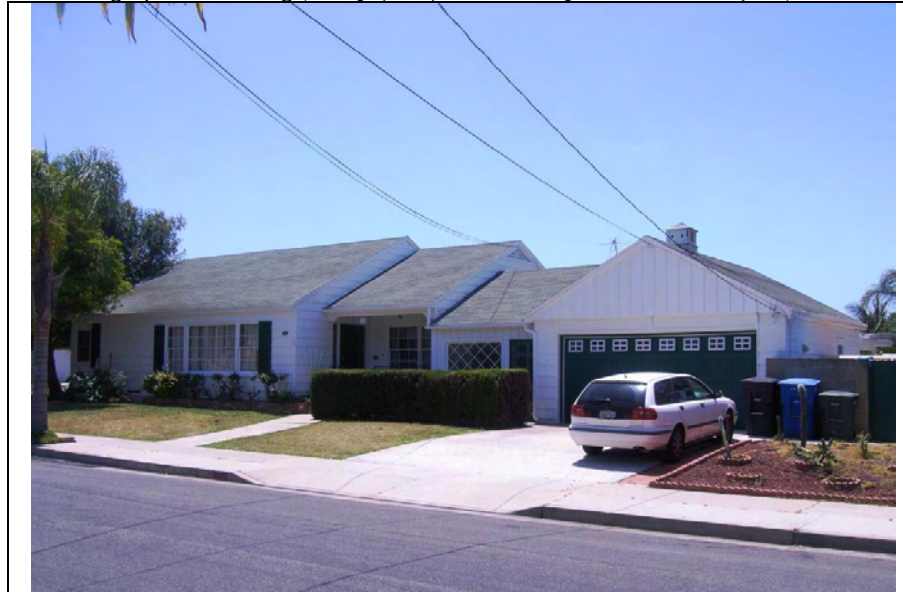
114 Guava Avenue was constructed in 1950 in the Custom Ranch style. It is a one-story single family residential building located on the west side of Guava Avenue, north of Marietta Street. The residence has a wood frame, rectangular floor plan with a concrete foundation. The exterior is clad in horizontal wood board siding. The roof is a moderately-pitched side gable roof with an asphalt roll. On the east elevation, a concrete walkway with steps leads to a recessed partial-width porch. The primary entrance is located within the porch and consists of a single wood door. The windows consist of double hung wood sashes and a diamond-pane fixed window. There is an attached front gable garage building on the west elevation. There is a chimney located within the roofline. Landscape features include a front yard and driveway.

View looking west at the building.

114 GUAVA AV is recommended eligible as a Chula Vista Historic Resource under NRHP, CRHR and local criteria. In considering the building within the historic context prepared for this survey, it does not appear to be associated with any significant themes or patterns in history and therefore not eligible for Criteria A or 1. Additionally, no significant persons were identified in association with the property and it is not recommended eligible under Criteria B or 2. 114 GUAVA AV as an excellent local example of the Custom Ranch style, and as such is recommended eligible as a Chula Vista Historic Resource under Criterion 3. Character defining features of the Custom Ranch style include the single story, rambling and long floor plan, widely-pitched gable roof, the attached garage, window shutters and recessed porch. Following the same reasons, it is also eligible for the California Register of Historical Resources and National Register of Historic Places, on the local level, under Criterion 3 (CRHR) and Criterion C (NRHP). The building retains a significant degree of its building materials dating to the period of significance, especially in comparison to other similar properties. Overall it retains a high degree of integrity, especially of design, materials, and craftsmanship.

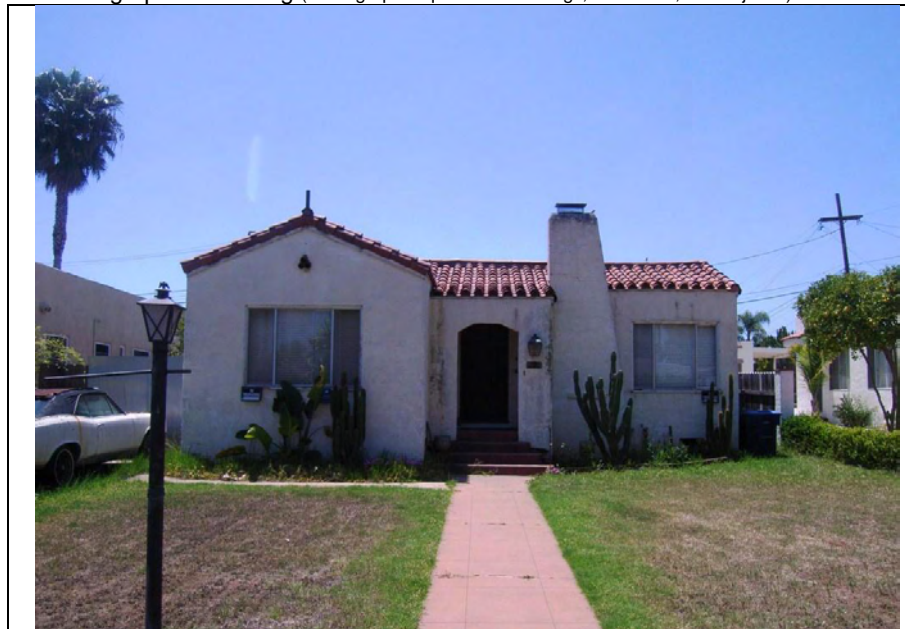
220 Guava Avenue was constructed in 1930 in the Spanish Colonial Revival style. It is a one-story single family residential building located on the west side of Guava Avenue, north of Davidson Street. The residence has a wood frame, rectangular floor plan with a concrete foundation. The exterior is clad in stucco siding. The roof is a moderately-pitched front and side gable roof and clad in red clay tiles. On the west elevation, a concrete walkway and steps lead to a partial-width recessed porch. The primary entrance is located within the porch and consists of a single wood door. The windows consist of aluminum sliding windows. There is a front chimney located on the west elevation exterior lateral. Modifications to the building include the replacement of windows and doors. There is a rear detached garage. Landscape features include a front yard, a side driveway and an iron gate leading to the rear garage.

View looking west at the building.

220 GUAVA AV is not recommended eligible as a Chula Vista Historic Resource under any NRHP or CRHR or local criteria. In considering the building within the historic context prepared for this survey, it does not appear to be associated with any significant themes or patterns in history and therefore not eligible for Criteria A or 1. Additionally, no significant persons were identified in association with the property and it is not recommended eligible under Criteria B or 2. Although 220 GUAVA AV possesses some stylistic features of the Spanish Colonial Revival style, it is not a good representative of the style and is not recommended eligible under Criteria C or 3.

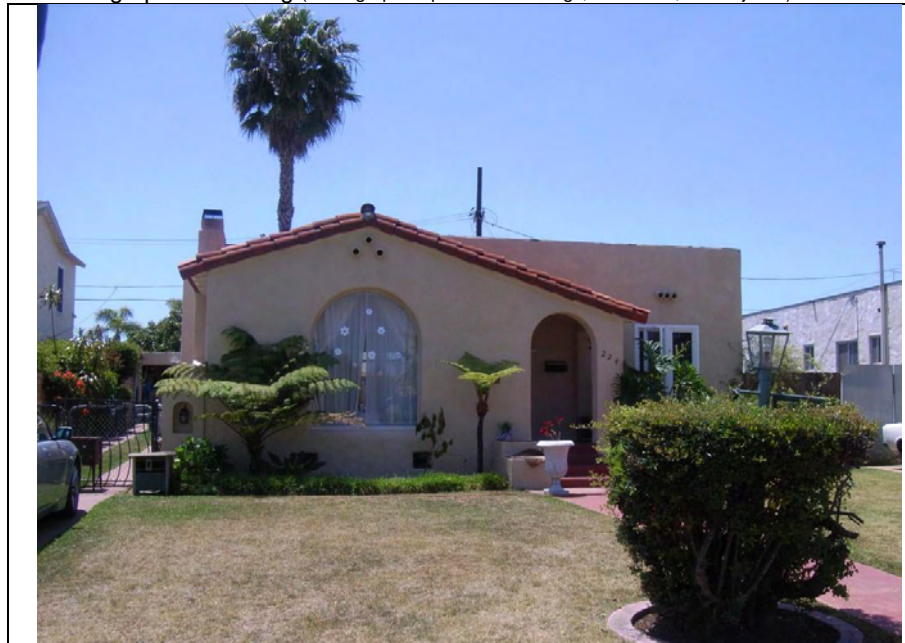
224 Guava Avenue was constructed in 1930 in the Spanish Colonial Revival style. It is a one-story single family residential building located on the east side of Guava Avenue. The residence has a wood frame, rectangular floor plan with a concrete foundation. The exterior is clad in stucco siding. The roof is flat with a raised parapet and a front gable projection over the porch clad in red clay tiles. On the east elevation, a concrete walkway and steps lead to a partial-width recessed porch. The primary entrance is located within the porch and consists of a single wood door. The windows consist of vinyl sliding windows. There is another arched fixed window. There is a chimney on the south elevation exterior lateral. Modifications to the building include the replacement of windows. A detached garage building is located to the rear of the parcel lot. Landscape features include a front yard and side driveway.

View looking west at the building.

224 GUAVA AV is recommended eligible as a Chula Vista Historic Resource under NRHP, CRHR and local criteria. In considering the building within the historic context prepared for this survey, it does not appear to be associated with any significant themes or patterns in history and therefore not eligible for Criteria A or 1. Additionally, no significant persons were identified in association with the property and it is not recommended eligible under Criteria B or 2. 224 GUAVA AV as an excellent local example of the Spanish Colonial Revival style, and as such is recommended eligible as a Chula Vista Historic Resource under Criterion 3. Character defining features of the Spanish Colonial Revival style include the arched windows and entryways, recessed porch, smooth stucco walls, and red clay tile roofing. Following the same reasons, it is also eligible for the California Register of Historical Resources and National Register of Historic Places, on the local level, under Criterion 3 (CRHR) and Criterion C (NRHP). The building retains a significant degree of its building materials dating to the period of significance, especially in comparison to other similar properties. Overall it retains a high degree of integrity, especially of design, materials, and craftsmanship.

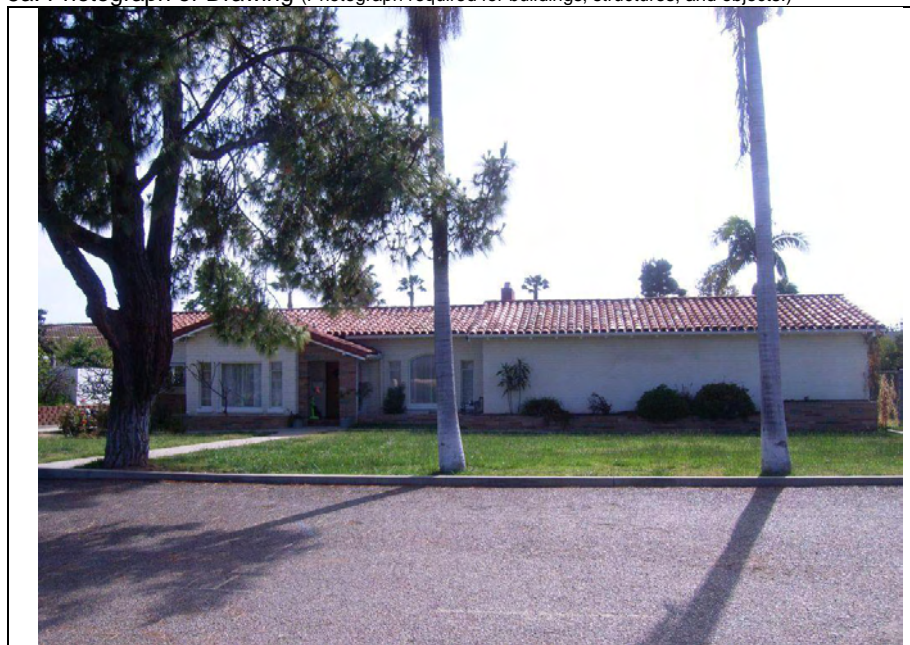
54 Hilltop Drive was constructed in 1939 in the Custom Ranch style. It is a one-story single family residential building located on the west side of Hilltop Drive, north of D Street. The residence has a wood frame, rectangular plan with a concrete foundation. The exterior is clad in brick siding with a brick veneer water table. The roof is a widely-pitched side gable roof with a front gable projection and clad in red clay tiles. On the west elevation, a concrete walkway lead to a partial-width recessed porch. The primary entrance is located within the porch and consists of a single wood door. The windows consist of fixed picture and wood sash windows. There is a rear detached two-story garage building to the rear of the property lot. There is one chimney located within the roof surface. There appear to be no modifications to the building. Landscape features include a front lawn and a side driveway.

View looking west at the building.

54 HILLTOP DR is recommended eligible as a Chula Vista Historic Resource under NRHP, CRHR and local criteria. In considering the building within the historic context prepared for this survey, it does not appear to be associated with any significant themes or patterns in history and therefore not eligible for Criteria A or 1. Additionally, no significant persons were identified in association with the property and it is not recommended eligible under Criteria B or 2. 54 HILLTOP DR as an excellent local example of the Custom Ranch style, and as such is recommended eligible as a Chula Vista Historic Resource under Criterion 3. Character defining features of the Custom Ranch style include the single story, the rambling floor plan, widely-pitched side gable roof, attached garage, shutters and recessed porch. Following the same reasons, it is also eligible for the California Register of Historical Resources and National Register of Historic Places, on the local level, under Criterion 3 (CRHR) and Criterion C (NRHP). The building retains a significant degree of its building materials dating to the period of significance, especially in comparison to other similar properties. Overall it retains a high degree of integrity, especially of design, materials, and craftsmanship.

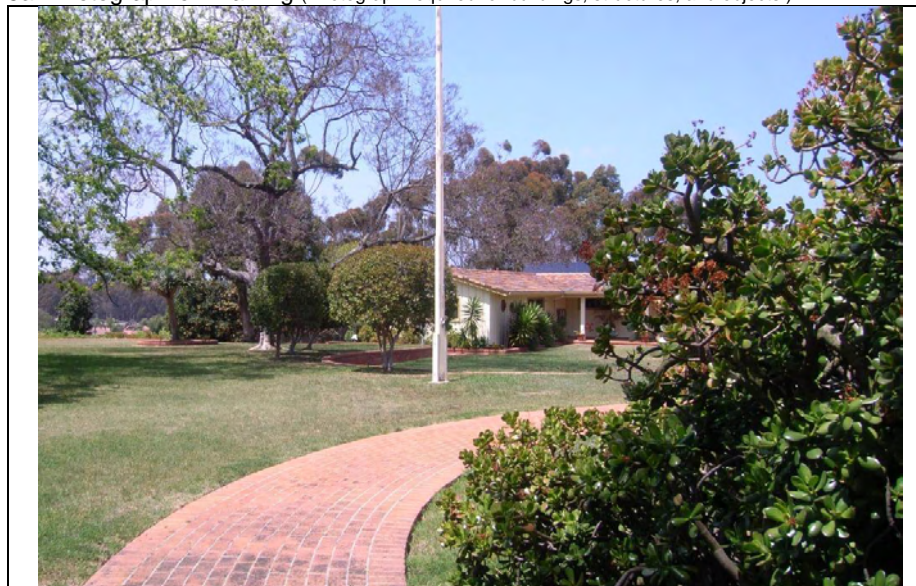
299 Hilltop Drive was constructed in 1937 in the Custom Ranch style. It is a one-story single family residential building located on the northeast side of Hilltop Drive. The residence has a wood frame, near U-shaped floor plan with a concrete foundation. The exterior is clad in vertical wood board siding. The roof is a front and side gable roof with overhanging eaves and clad in red clay tiles. The primary entrance is located within the southwest elevation but could not be seen from the street at the time of the survey. The windows consist of wood casement windows. Landscape features include a front yard and a brick wall with mature trees. There is an iron fence that surrounds the property.

View of part of the building looking  
northeast. Photo taken May 11, 2012.

299 HILLTOP DR is recommended eligible as a Chula Vista Historic Resource under NRHP, CRHR and local criteria. In considering the building within the historic context prepared for this survey, it does not appear to be associated with any significant themes or patterns in history and therefore not eligible for Criteria A or 1. Additionally, no significant persons were identified in association with the property and it is not recommended eligible under Criteria B or 2. 299 HILLTOP DR as an excellent local example of the Custom Ranch style, and as such is recommended eligible as a Chula Vista Historic Resource under Criterion 3. Character defining features of the Custom Ranch style include the rambling floor plan, widely-pitched roof, recessed entrance and porch. Following the same reasons, it is also eligible for the California Register of Historical Resources and National Register of Historic Places, on the local level, under Criterion 3 (CRHR) and Criterion C (NRHP). The building retains a significant degree of its building materials dating to the period of significance, especially in comparison to other similar properties. Overall it retains a high degree of integrity, especially of design, materials, and craftsmanship.

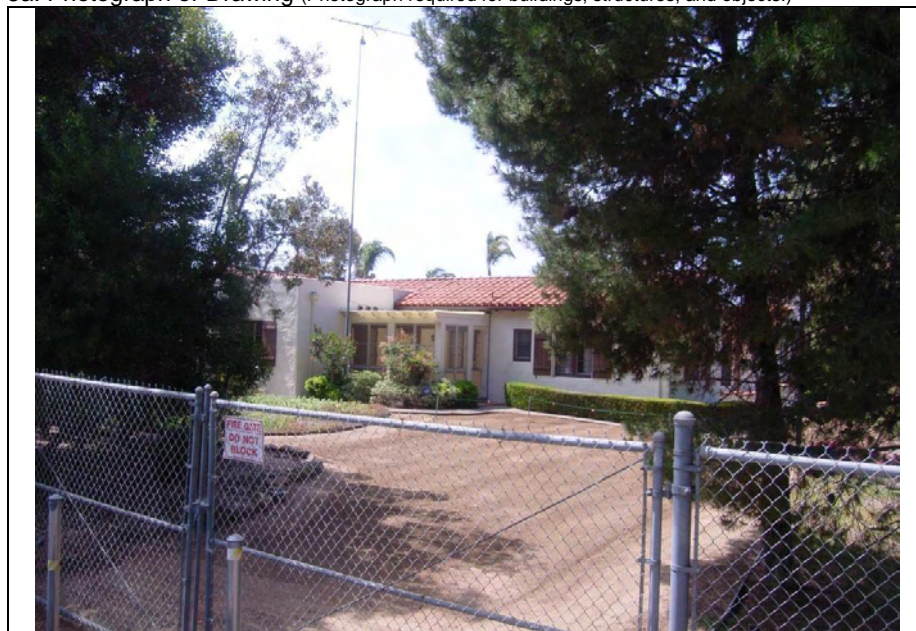
345 Hilltop Drive was constructed in 1929 in the Spanish Colonial Revival style. It is a one-story single family residential building located on the north side of Lion Circle, west of Hilltop Drive. The residence has a wood frame, U-shaped floor plan with a concrete foundation and a central open courtyard. The exterior is clad in stucco siding. The roof is a widely-pitched front and side gable roof with widely overhanging eaves and clad in red clay tiles. On the west elevation, a long driveway leads to the primary entryway which could not be seen from the street at the time of the survey. The windows consist of wood casement windows with shutters. There are two chimneys, one is on the east elevation exterior lateral and one within the roof surface. Additions include a one-story enclosed entryway on the south elevation. There appear to be no modifications to the building. Landscape features include a central courtyard and surrounding mature trees and a grass lawn.

View looking north at the building.

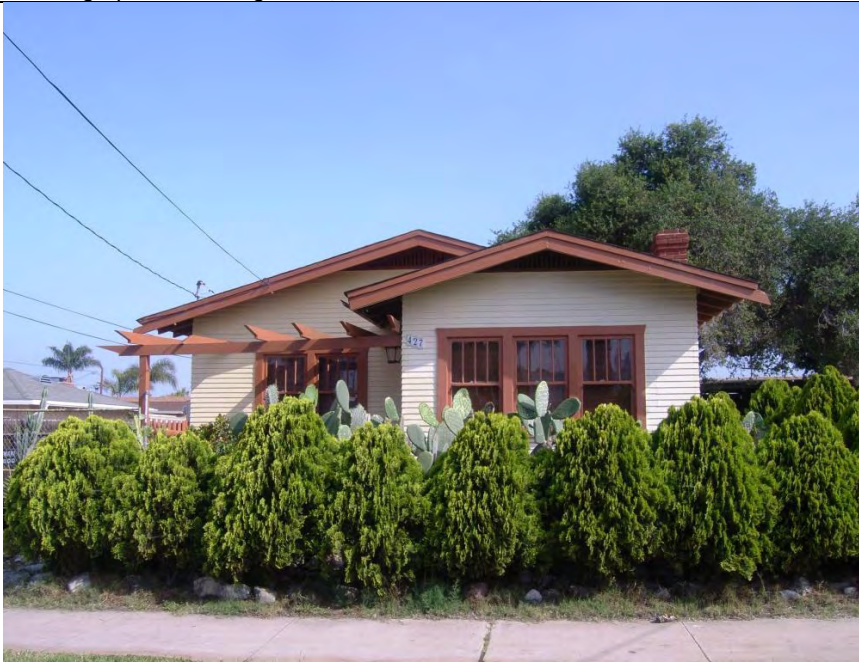
427 J Street was constructed in 1926 in the Craftsman style. It is a one-story single family residential building located on the north side of J Street between Fourth and Fig avenues. The residence has a wood frame, rectangular floor plan with a concrete foundation. The exterior is clad in wood clapboard siding. The roof is a moderately-pitched front gable roof with overhanging eaves and clad in asphalt roll. On the south elevation, concrete steps with a wood railing lead to a partial-width porch with a pergola roof. The primary entrance is located within the porch and consists of a single wood door. The windows consist of double hung wood sash windows with four-over-one lights. There is one chimney on the east elevation interior lateral. There is a two-car detached garage located at the rear of the property lot. There appear to be no modifications to the building. Landscape features include mature trees and a small grass lawn.

View looking north at the building.

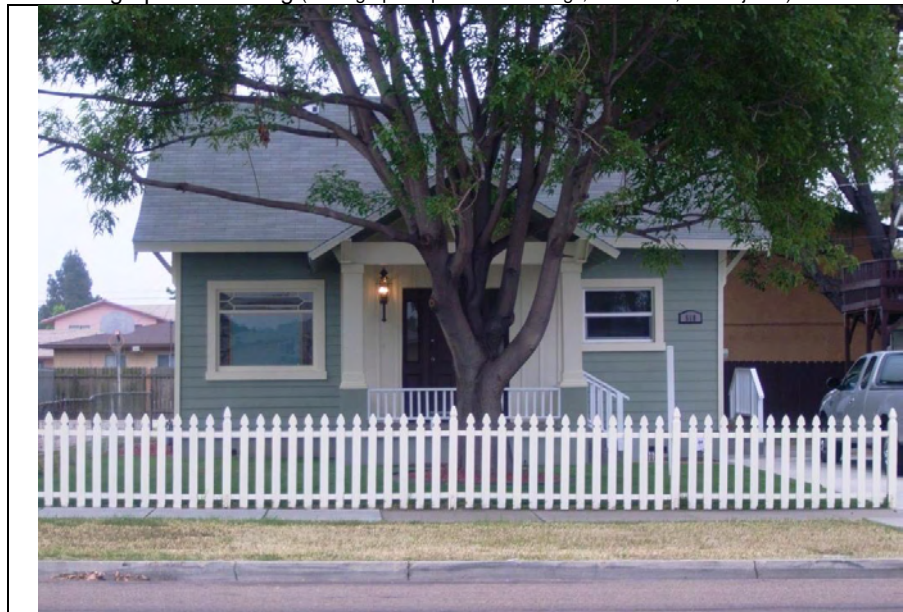
558 J Street was constructed in circa 1940 in the Craftsman style. It is a one- and one-half story single family residential building located on the south side of J Street between Broadway and Fifth Avenue. The residence has a wood frame, rectangular floor plan with a concrete foundation. The exterior is clad in wood clapboard siding. The roof is a moderately-pitched side gable roof with widely overhanging eaves and clad in an asphalt roll. On the north elevation, a concrete walkway and steps lead to a partial-width porch with a front gable roof. The primary entrance is located within the porch and consists of a single wood paneled door with sidelights. The windows consist of wood fixed window and vinyl sash windows. There is a detached garage with rooms on the upper story of the garage building. Modifications to the building include the replacement of windows and doors. Landscape features include a front lawn and a white picket fence surrounding the property.

View looking south at the property.

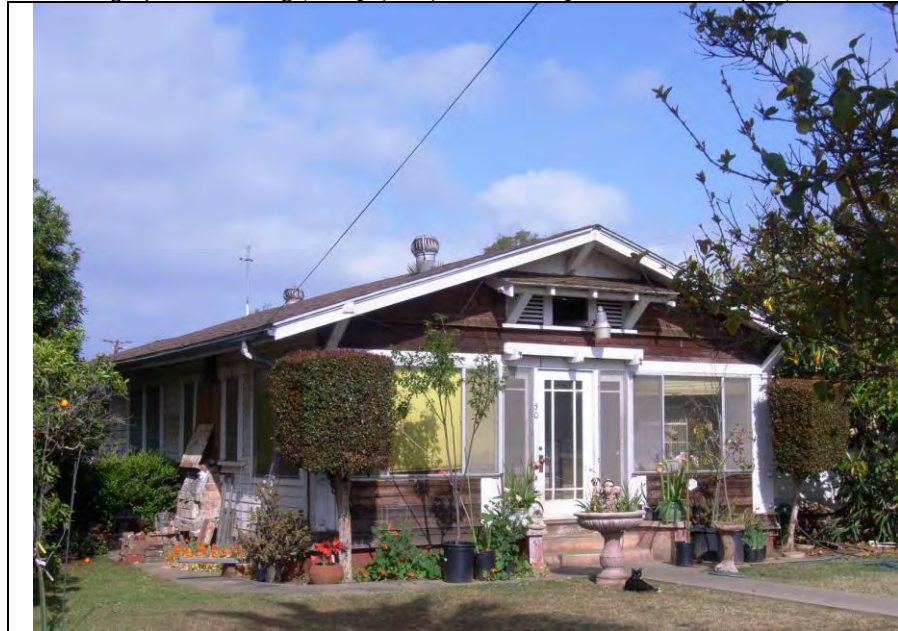
50 Madison Avenue was constructed in 1928 in the Craftsman style. It is a one-story single family residential building located on the west side of Madison Avenue. The residence has a wood frame, rectangular floor plan with a concrete foundation. The exterior is clad in wood clapboard siding. The roof is a widely-pitched front gable roof with widely-overhanging eaves, and exposed knee brackets and clad in asphalt shingles. On the east elevation, a concrete walkway and steps lead to an open stoop. The primary entrance is located within the stoop and consists of a glazed door flanked by sidelights. The windows consist of aluminum sliding windows. The porch has been enclosed. Modifications to the building include the porch enclosure. Landscape features include a fenced-in yard. There is also a rear detached garage building on the parcel lot.

View looking east at the building.

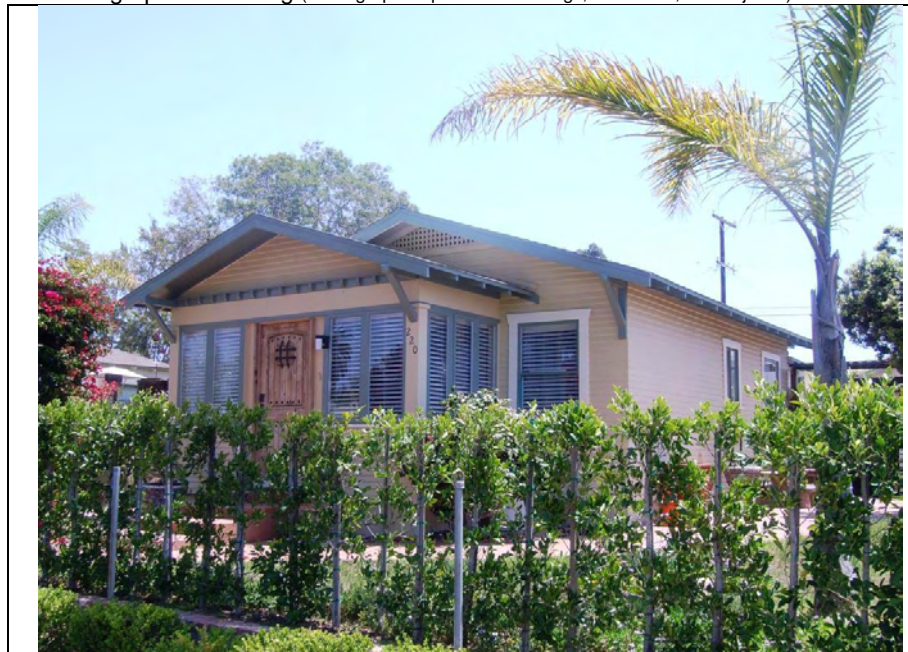
220 Madrona Street was constructed in 1947 in the Craftsman style. It is a one-story single family residential building located on the south side of Madrona Street between Second and Third avenues. The residence has a wood frame, rectangular floor plan with a concrete foundation. The exterior is clad in wood clapboard siding. The roof is a widely-pitched front gable roof with overhanging eaves, exposed rafter tails and knee brackets and clad in asphalt shingles. On the north elevation, a concrete walkway leads to an open stoop with a front gable roof. The porch is enclosed and has narrow casement windows. The primary entrance is located on the stoop and consists of paneled wood door. The windows consist of double hung wood sash windows. There is a vent underneath the front gable. Modifications to the building include the replacement of windows and doors. Landscape features include a concrete walkway and grass lawn surrounding the house.

View looking south at the building.

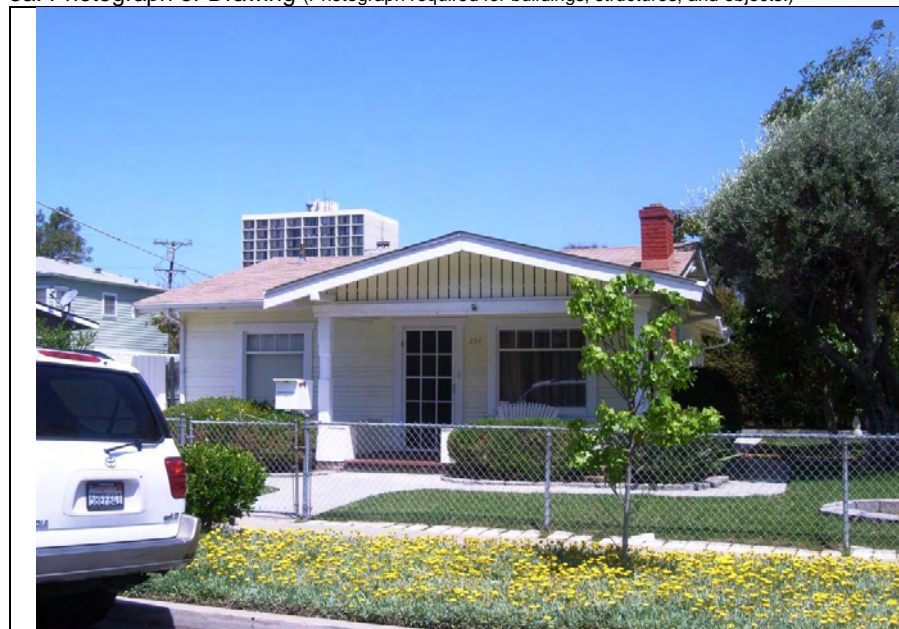
251 Madrona Street was constructed in 1923 in the Craftsman style. It is a one-story single family residential building located on the north side of Madrona Street between Del Mar and Church avenues. The residence has a wood frame, rectangular floor plan with a concrete foundation. The exterior is clad in horizontal wood board siding. The roof is a widely-pitched side gable roof with overhanging eaves and clad in an asphalt roll. On the south elevation, a concrete walkway and step leads to a partial-width porch with a front gable roof. The primary entrance is located within the porch and consists of a wood door with full glazing. The windows consist of fixed picture windows. There is one chimney on the east elevation exterior lateral. Modifications to the building include the replacement of the front door. Landscape features include a grass lawn and a chain-link fence surrounding the property lot. There is a detached garage on the property.

View looking north at the building.

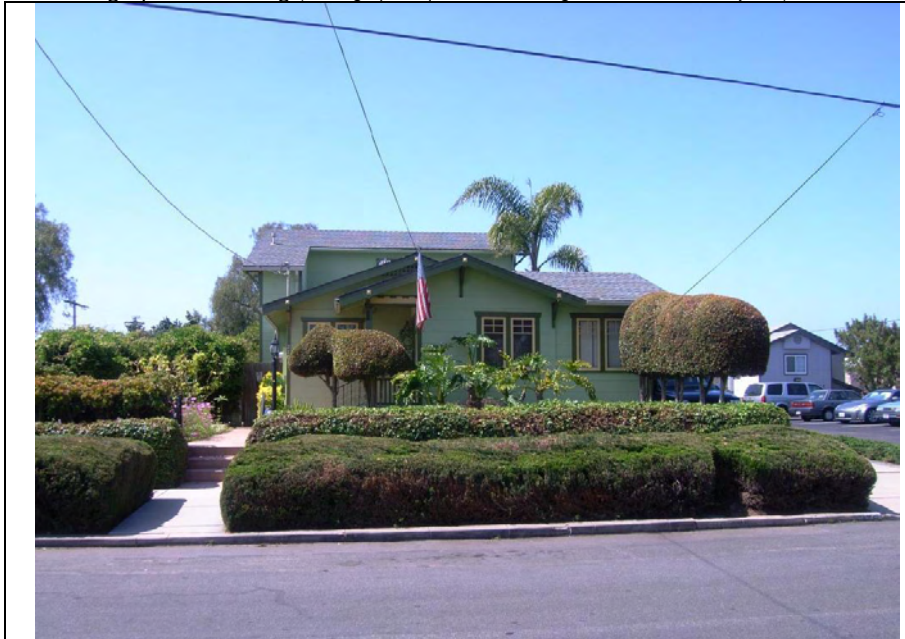
270 Madrona Street was constructed in 1932 in the Craftsman style. It is a one- and two-story single family residential building located on the south side of Madrona Street between Del Mar and Third avenues. The residence has a wood frame, rectangular floor plan with a concrete foundation. The exterior is clad in aluminum siding. The roof is a widely-pitched front and side gable roof with overhanging eaves and clad in asphalt shingles. On the south elevation, a concrete walkway with steps lead to a partial-width recessed porch. A squared wooden post and iron railing line the porch. The primary entrance is located within the porch and consists of a single wood door. The windows consist of wood casement, sash and aluminum sliding windows. Additions include a large two-story rear addition. Modifications to the building include replacement siding, windows and doors as well as the large rear addition. Landscape features include a grass lawn and flowerbeds.

View looking west at the building.

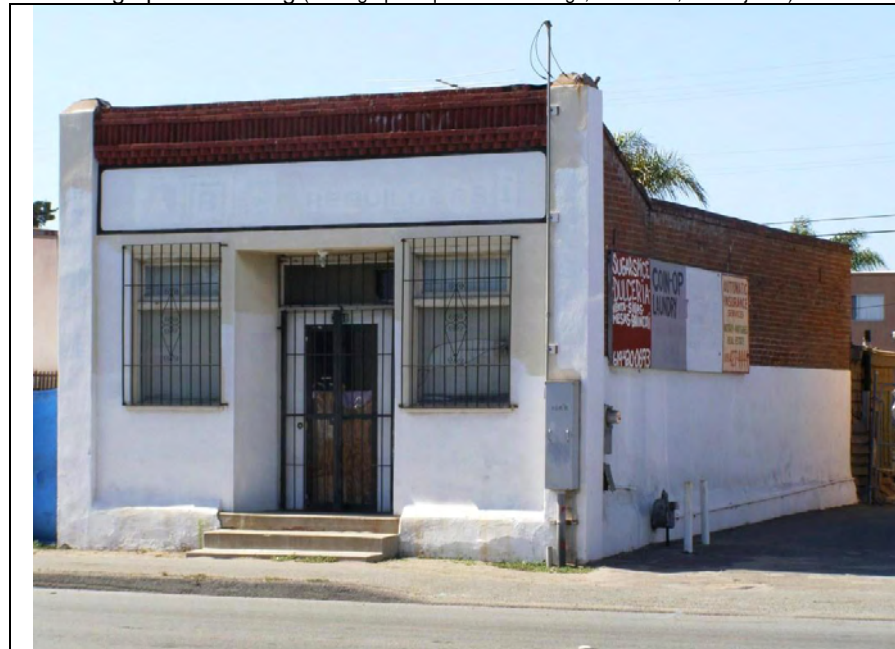
3148 Main Street was constructed in 1899 in the Pre-War Commercial style. It is a one-story commercial building located on the north side of Main Street between Third and Fresno avenues. The commercial building has a wood frame, rectangular floor plan with a concrete foundation. The exterior is clad in concrete and exposed brick siding. The roof is flat with a raised parapet. Along the cornice of the roofline is a row of dentils in brick. On the south elevation, concrete steps lead to a partial-width angled storefront entryway. The primary entrance is located within the porch and consists of two wood doors with partial glazing. The windows consist of fixed wood windows with transoms. There are metal security bars over the windows.

View looking northwest at the building.

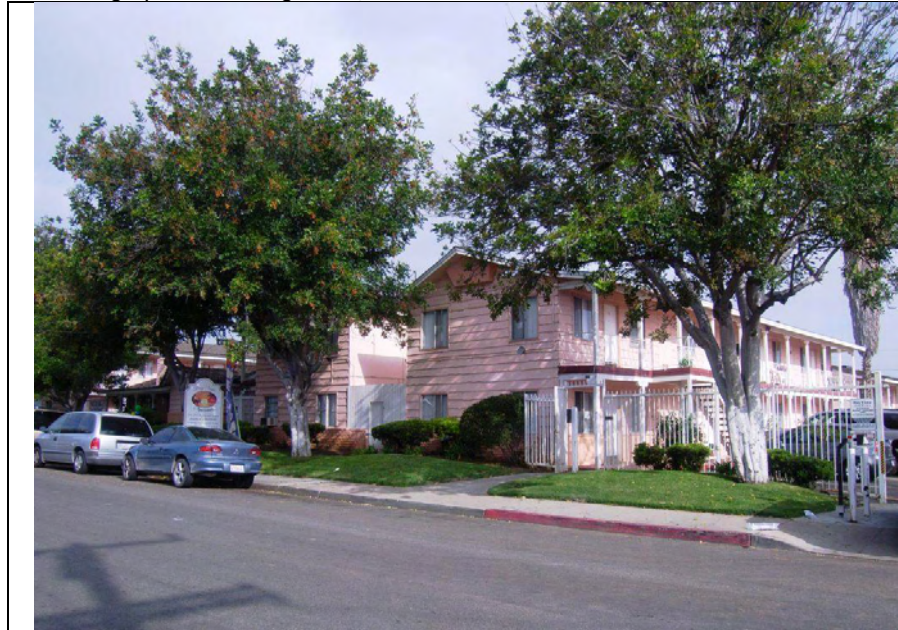
View looking northeast at the complex.

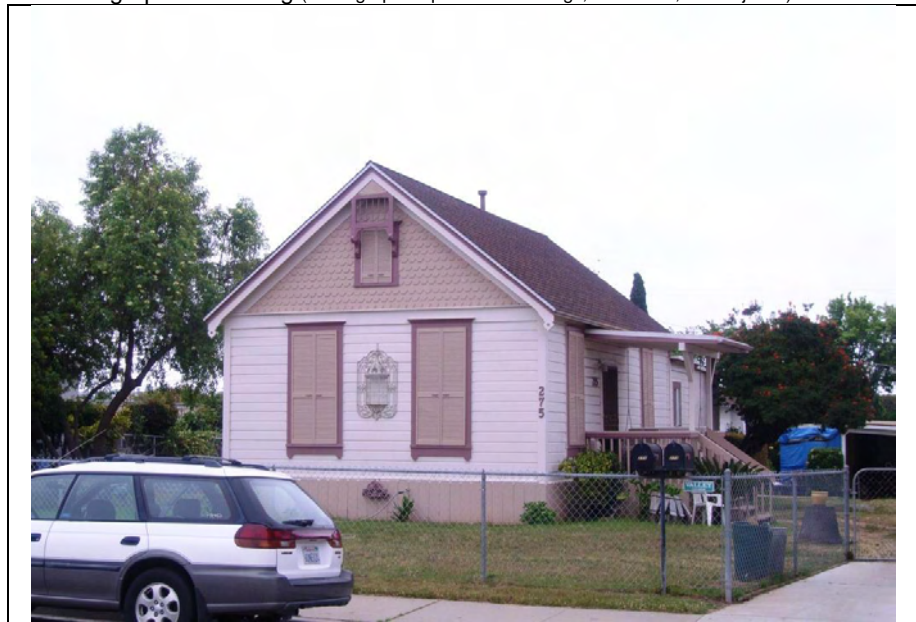
275 Montgomery Street was constructed in 1899 with features of the Queen Anne style. It is a one- and one-half story building located on the south side of Montgomery Street between Del Monte and Third avenues. The residence has a wood frame, rectangular floor plan with a concrete foundation. The exterior is clad in channel drop wood siding with patterned shingles underneath the gables. The roof is a moderately-pitched side gable roof with shallow eaves and clad in asphalt shingles. On the west elevation, a concrete walkway and wood steps with a wood railing lead to a partial-width porch with a shed roof extension from the main roof. The primary entrance is located within the porch and consists of a single door obscured by a metal security door. The windows could not be seen at the time of the survey because they were covered by shutters. Modifications to the building include the replacement siding as well as the addition of Queen Anne features such as the decorative bargeboard, shutters, and ornamental gable ends. Landscape features include a grass lawn and chain-link fence surrounding the property.

View looking southeast at the building.

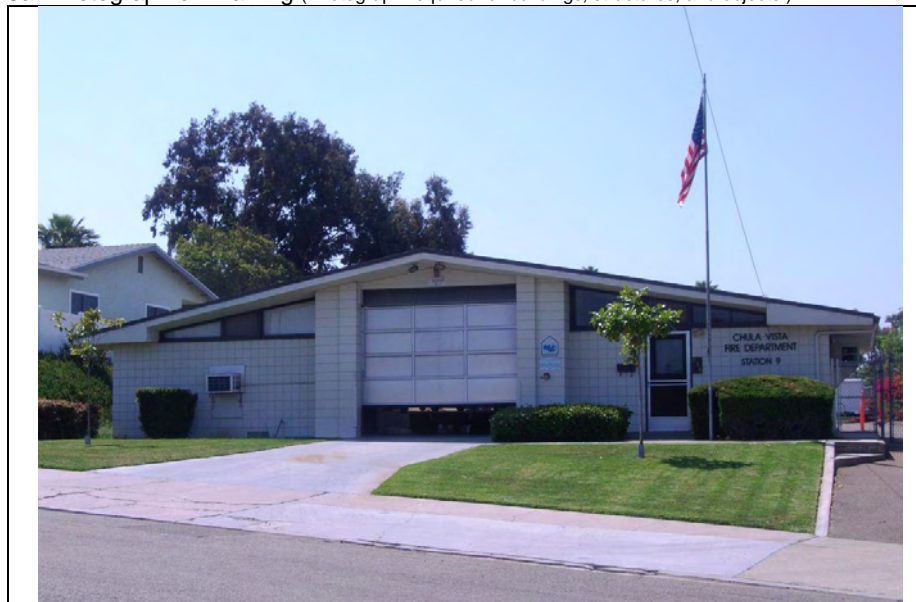
266 E. Oneida Street was constructed in 1960 in the Modern non-residential style. It is a one-story fire station located on the south side of E. Oneida Street between Nolan and Melrose avenues. The civic building has a wood frame, square floor plan with a concrete foundation. The exterior is clad in square tile siding. The roof is a widely-pitched front gable roof with overhanging eaves and clad in an asphalt roll. On the north elevation, a concrete driveway leads to an open stoop. There is a large garage with a metal roll-top door on the north façade. The primary entrance is located within the porch and consists of a partially-glazed wood door. The windows consist of fixed windows underneath the front gable and aluminum sliders. There is a large asphalt drive at the rear of the building. There appear to be no modifications to the building. Landscape features include a front lawn and driveway with a flag pole. There is a sign on the building which reads, "Chula Vista Fire Department Station 9."

View looking south at the building.
